Site ID: 13

Site Name: Southcroft Football Park

Site Name: Foundry, Govan Iron Works

Site 23

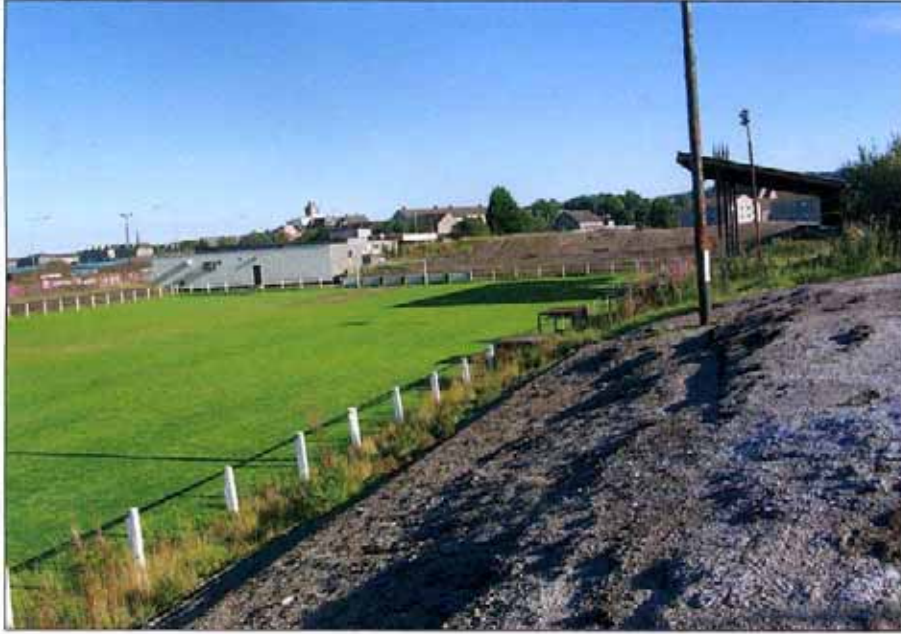
Site 13 – Southcroft Football Park

Standing building and earthworks. Corrugated iron roofing over terraces at SW end is in poor condition, as are other ground fittings.

Standing building survey. The site merits a rapid survey prior to destruction at Level 1, incorporating elements of Level 2 if deemed necessary (cf section 6.3 of Part 1 of this report). The record will comprise general photographs of the buildings/stands and any more detailed shots identified as relevant while undertaking the survey. A written record should be maintained to accompany and explain the photographs taken, their subjects, and any additional information relevant in understanding the selection of particular shots or the content of the photographs. A written description of the site and its development will also be necessary. Current and historic mapping should be checked with the remains on the ground; if this adequately represents the layout of the site then no further plan recording will be necessary. Amendments to the maps might be recorded in written form unless deemed particularly significant, in which case a plan survey should be undertaken.

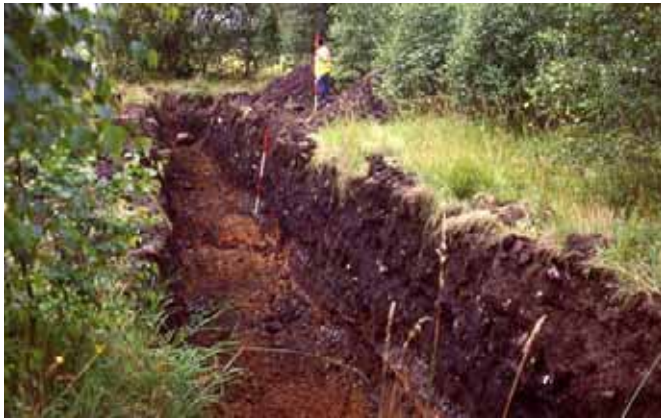
- Tr 1 This curving trench ran through the position of two structures shown on the OS first edition. The trench was dominated by extensive dumps of coal ash, slag, and ironworking residues, and building materials were encountered in large quantities to a depth of between 2 and 3 m. Small portions of *in situ* building remains were encountered and these were explored in Tr 2 and Tr 9.

GIW Tr1 Machine dug trench (TR1) through build up of iron working debris over the natural subsoil.

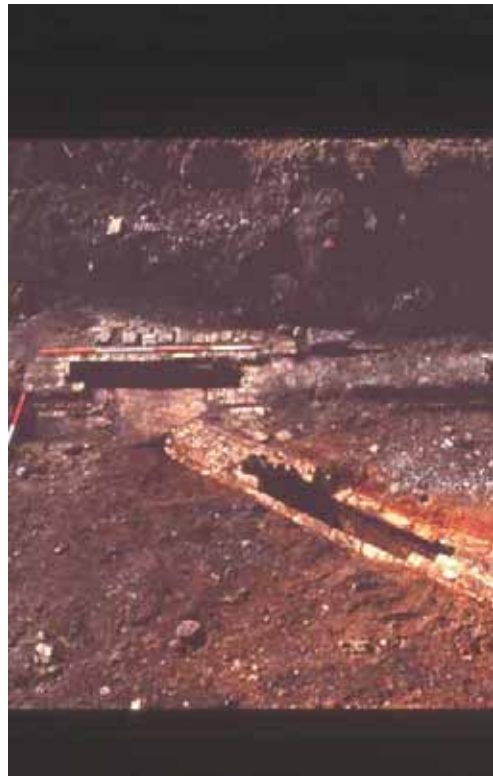
- Tr 2 In this trench, deep deposits of well-stratified ironworking waste sealed a series of brick- built structures – perhaps smithing forges. Associated with these structures was a brick-built conduit which showed evidence of having been exposed to intense heat (the conduit is possibly a hot-air duct associated with the ventilation of furnaces on this part of the site). To the south of these structures were vestigial remains of an external brick wall. The top of the conduit probably marks the approximate floor level of the workshop.

GIW Tr2 Machine dug trench (TR2) in the area of the fitting shop showing the base of a forge with a white brick air intake in the foreground.

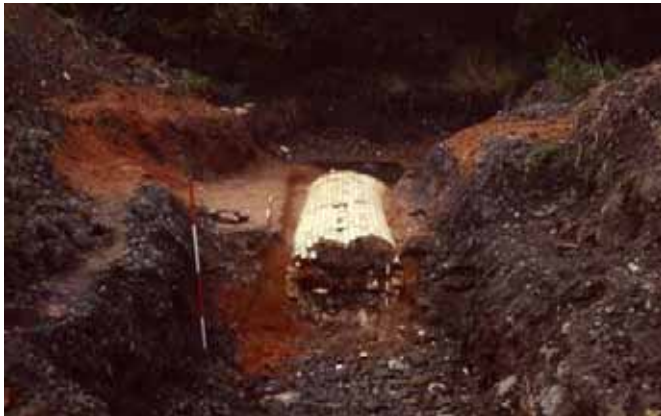
- Tr 4 In this trench, a section of a large brick-built conduit was exposed approximately 1 m below ground level. The east end was truncated and all contemporary features (such as a building wall) had been swept away. Towards the west, the conduit ran downwards at a steep angle. The conduit was empty and showed signs of having been exposed to intense heat, perhaps from hot gasses or hot air associated with furnace ventilation. This feature probably lay below the working level of the foundry.

GIW Tr4 Machine dug trench (TR4) revealing large white brick air intake approximately 1 m in diameter.

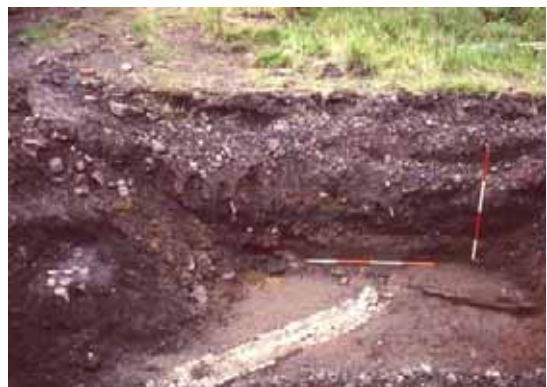
- Tr 7 Fragments of a cobble surface were encountered. Below this were two small, brick-built drains. These deposits were located below quantities of ironworking waste. It is not clear whether these are interior or exterior features.

GIW Tr7 Machine dug trench (TR7) revealing cobbled surface (in left section), above brick floor and brick-built drain.

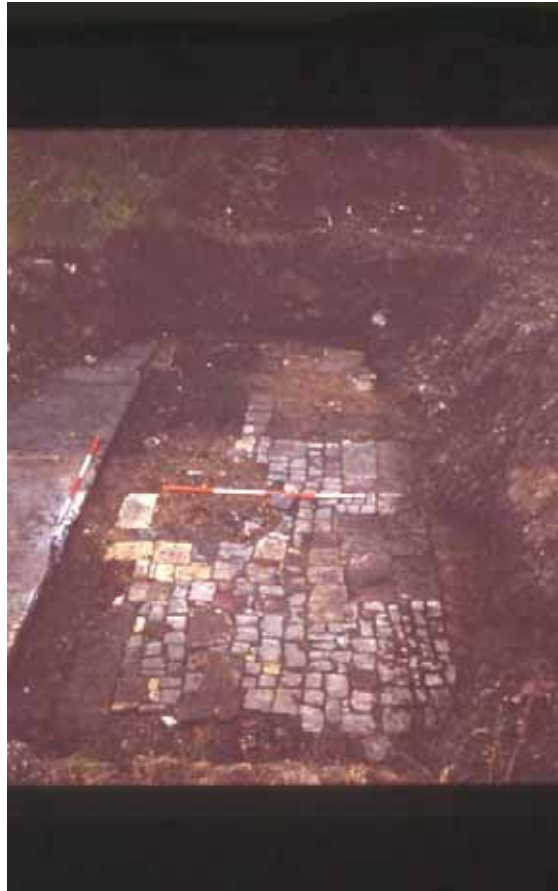
GIW Tr9 Machine dug trench (TR9) showing paved interior of workshop (right) and tarmac surface exterior.

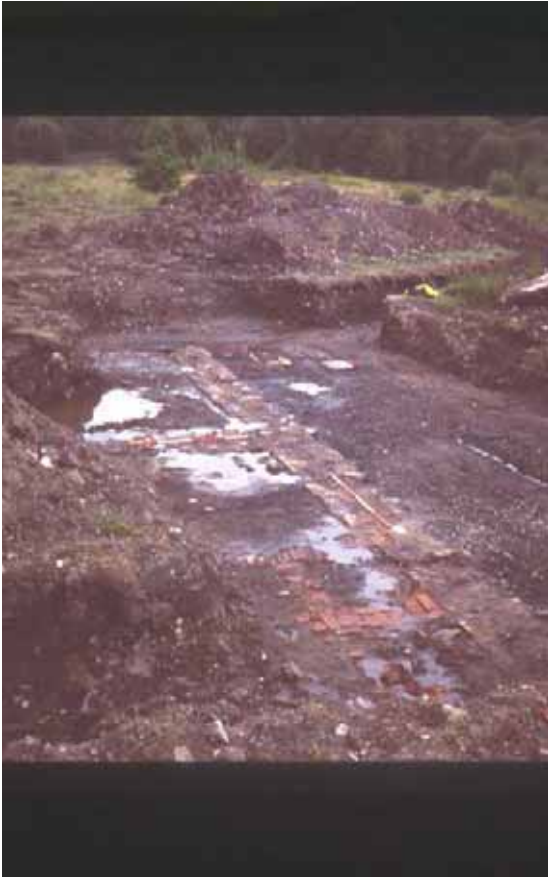
Trench 11 showing stone built wall of southern row with brick-built additions.

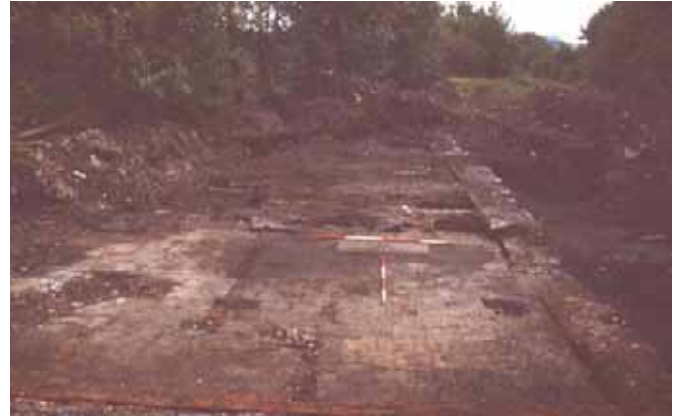
Trench 13 showing stone walls of southern row and tile floor paving.

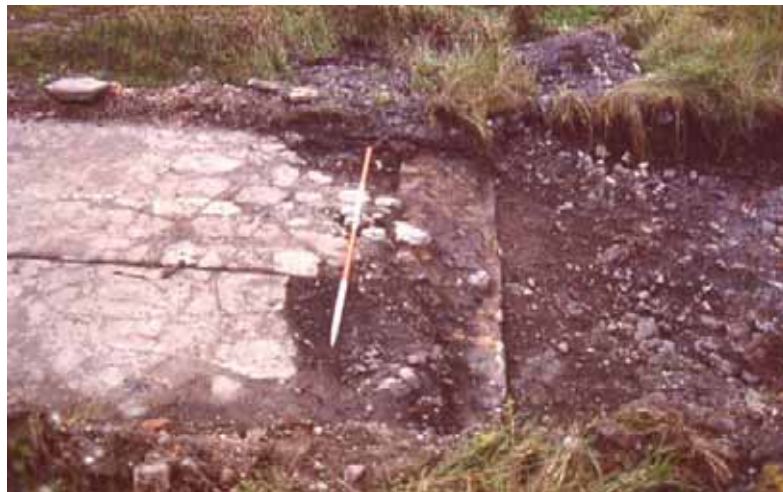
- Tr 14 Few archaeological traces here. Ground heavily disturbed, though elements of concrete and brick surface do survive.
- Tr 15 Although the ground here had been disturbed, some *in situ* building remains were encountered. These are probably part of the northern row (including various surfaces such as a brick floor, and wall foundations).

Trench 15 showing stone built foundations and cement surfaces.

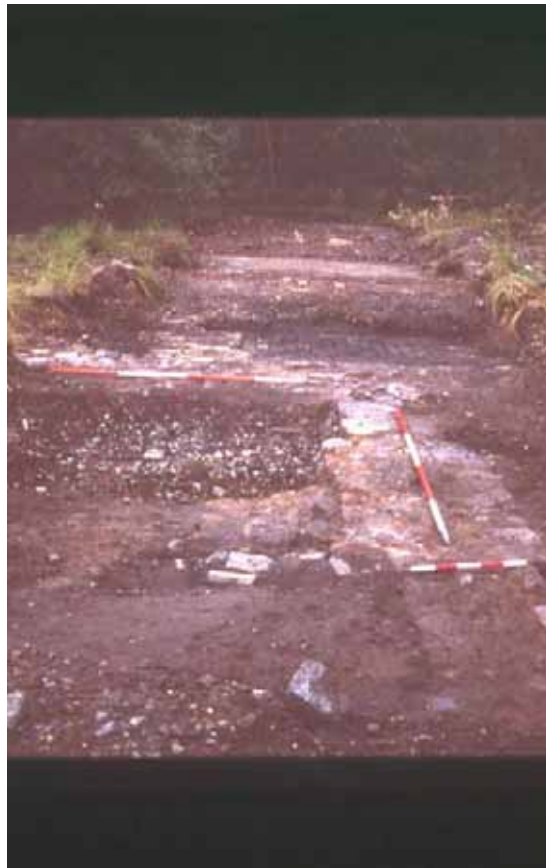
Trench 16 Various structures within northern row including stone foundations, brick floors, cement surfaces.

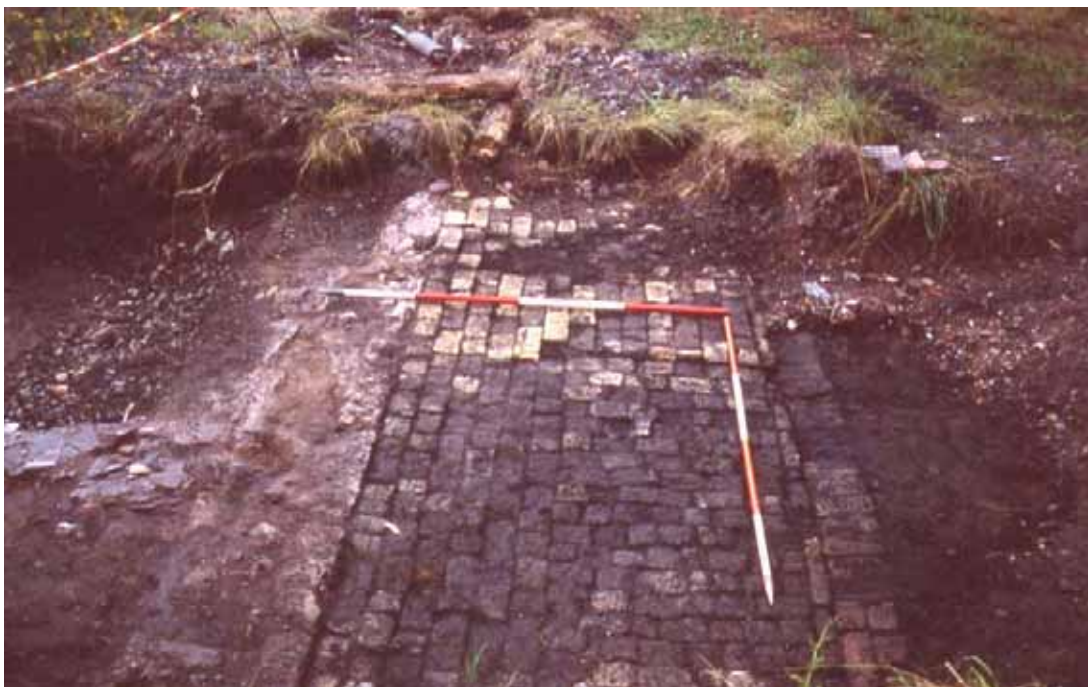
Trench 16 Various structures associated with northern row. Stone foundations (left) and brick road.
