### 3.0 Site by Site Assessments and Mitigation Proposals

Site ID: 6

Site Name: Clyde Waterproof Works

Site 6 – Clyde Waterproof Clothworks

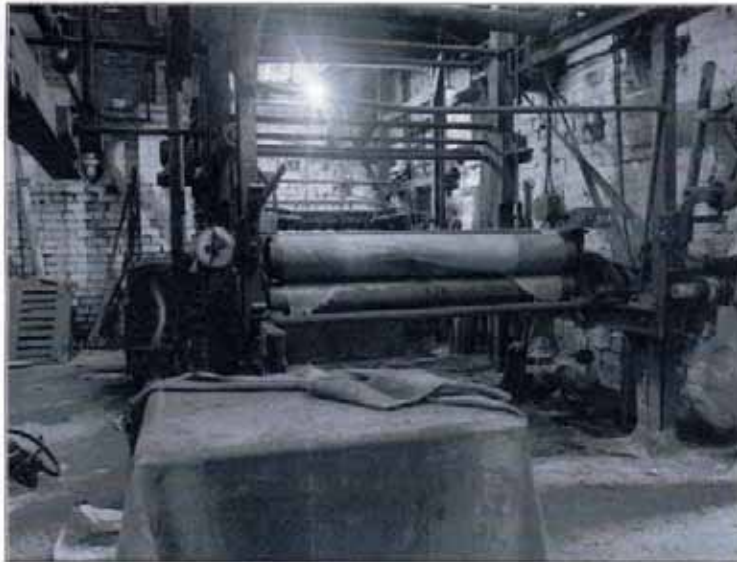
Rolling machine that coated the cloth with gas proof chemicals  
SCRAN ID 000-000-184-767-C

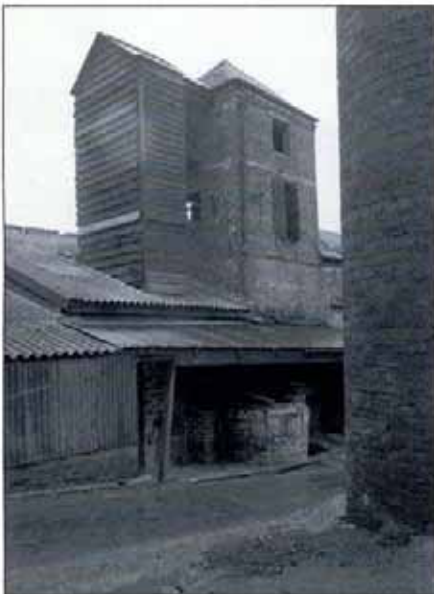
Drying tower  
SCRAN ID 000-000-184-766-C

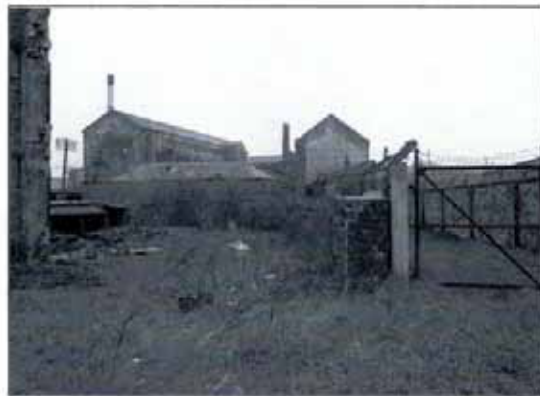
General View  
SCRAN ID 000-000-184-765-C

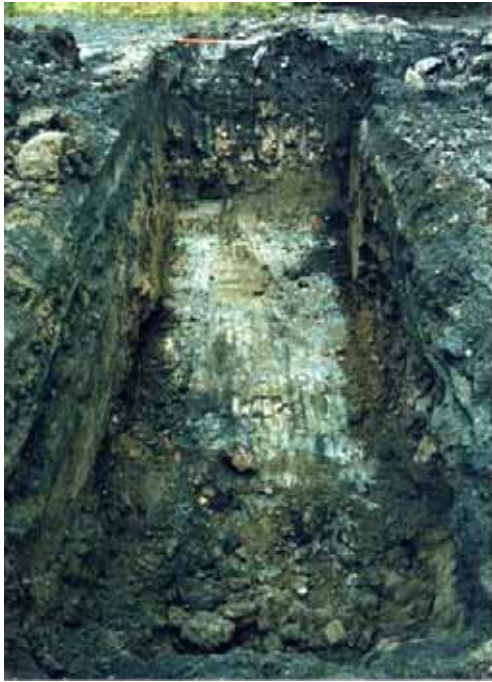
Trench 1 (7 m by 2.4 m by 1.8 m maximum depth)

Located within the main concrete surface on the north side of the site. Excavation revealed that beneath the concrete and bedding material (up to 0.8 m deep) was a deep deposit of clay over 1 m deep that

sealed a brick floor. This surface survived over most of the trench area and is presumed to represent the factory floor of the pottery.

Tr1 Machine dug trench revealing brick floor of pottery works.

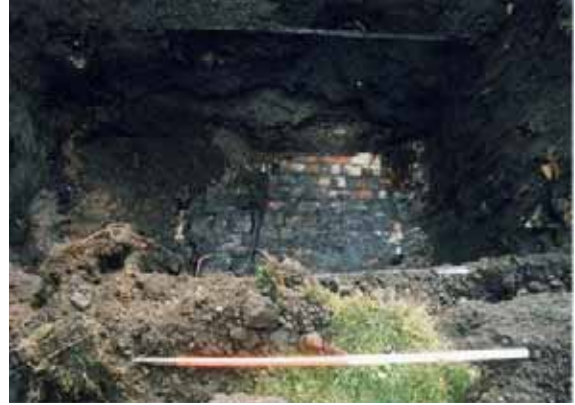
Trench 2 (9.7 m by 3.5 m by 3 m)

This trench was located as an extension to test pit S175. Excavation revealed that beneath the concrete and bedding material was a layer of rubble including a concentration of red bricks and an extensive layer of brown silty sand. Further excavation revealed that the red-brick rubble originated from a brick wall that runs east/west. This may represent the southern exterior wall of the pottery. To the south of the wall a concrete or cement floor surface was revealed at a depth of 1.6 m. To the north of the wall the brown sand layer sealed a loose voided deposit of demolition material including blocks of masonry. Further excavation through this material uncovered a substantial brick-built drain or culvert at a depth of 2.7 m. This drain appeared to contain white-pale grey clay (or clay slip).

Tr2 Machine dug trench revealing brick floor of pottery works.

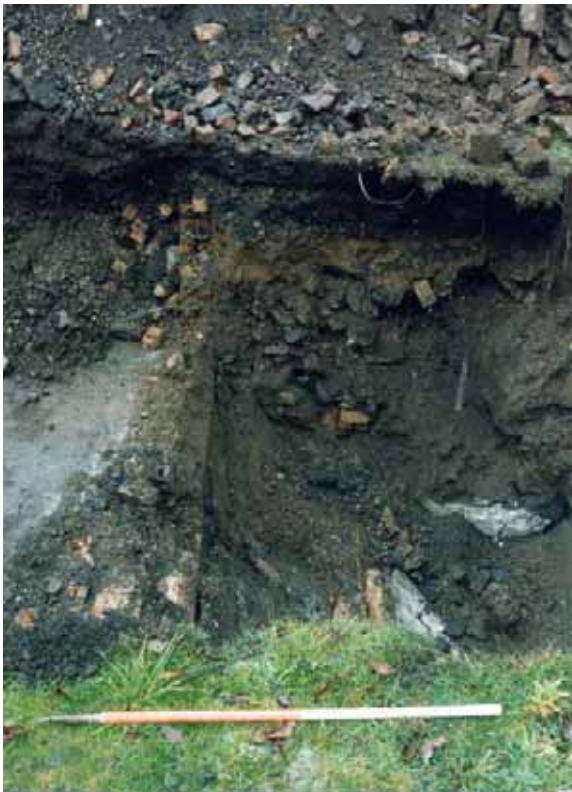
Trench 4 (3.4 m by 2.2 m by 2 m maximum depth)

Excavation revealed a deep deposit of mixed rubble debris up to 2 m deep that covered a brick surface, which ran over most of the trench. At the west side of the trench two drains were uncovered at the edge of the brick floor.

Tr4 Machine dug trench revealing exterior surface (?), southern wall of pottery works in section and within the pottery works a drain filled with pottery wasters and a white clay deposit (right).

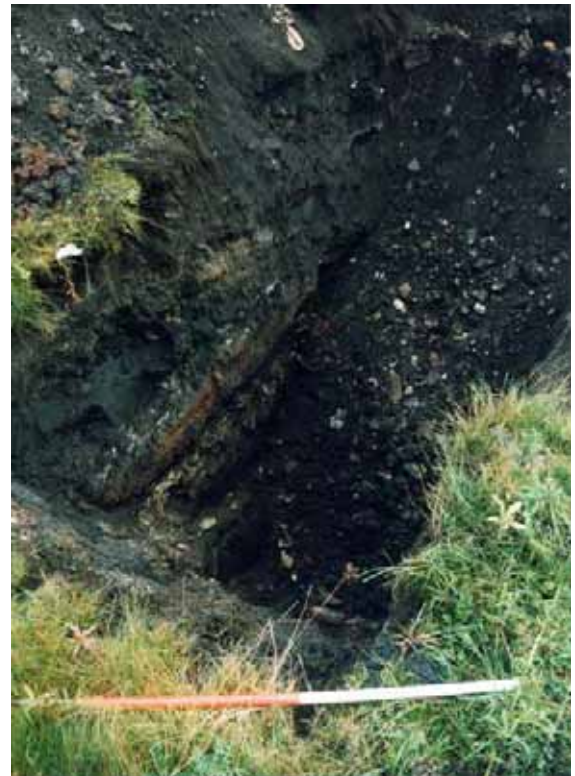
Trench 5 (4.5 m by 2.2 m by 3.2 m)

Excavation revealed that beneath the topsoil and overburden were several layers of mixed ash, sand and rubble that appear to form discrete tip lines in section. At a depth of 1.7 m these layers sealed a level layer of ash which in turn sealed a layer of debris consisting almost entirely of pottery sherds 0.2 m thick. Beneath this was a layer of ash 0.8 m deep.

Tr5 Machine dug trench through extensive waste deposits to the east of the factory showing the stratigraphy of the deposits incorporating pottery wasters, saggars, kiln waste and fuel ash.
